# Manhole Inspection Summary

Manhole # S41W1\_002MH

Insp Date: **12/6/07 9:21 AM**

**Location** Address: **3466 6th St**

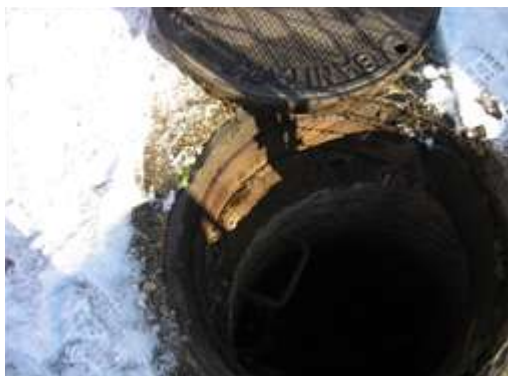
Steps

Count: **3** Missing: **0** ☐ Corroded

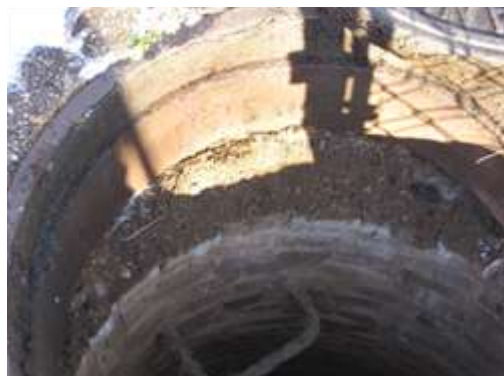
Defect 1

Offset: **6** (in.)

Frame offset

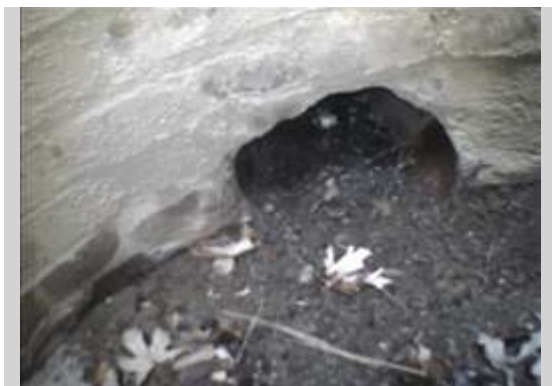
12 O'Clock Outflow

8 in. Circular Gravity Sewer  
Pipe Out @ 12 O'Clock

Pipe Height: **10.8** (in.) Rod and Bar (Angled)

Pipe Material: **Clay** ☐ Pipe Lined

Invert Depth: **7.26** (ft.) Flow Characteristics: **None**

Infiltration: **None** Pipe Seal Cond: **Sound**
